CID-720 AIRCRAFT
HIGH-ENVIRONMENT
FLIGHT INSTRUMENTATION SYSTEM

R. S. Calloway
NASA Langley Research Center
Hampton, Virginia

NASA/FAA Government/Industry CID Workshop
NASA Langley Research Center
April 10, 1985

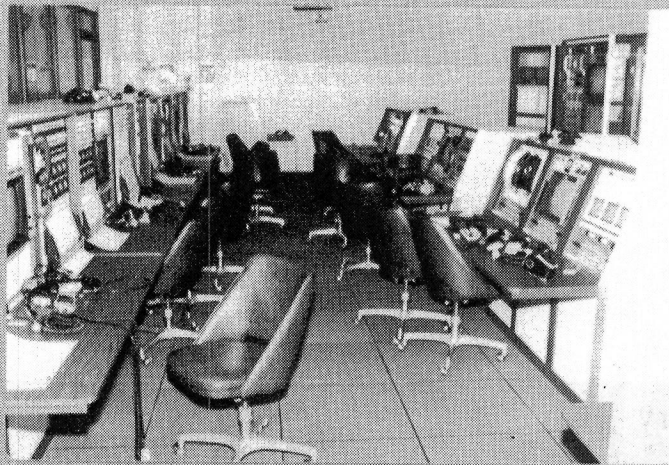
Main Control Room (MCR)

There was capability to monitor data system #2 in the Spectrum Analysis Facility and data system #1 in the Main Control Room. The selected subsystem parameters and data channels were monitored real-time to establish mission readiness. There was a communication net available for communications between the control rooms and the remote vans.

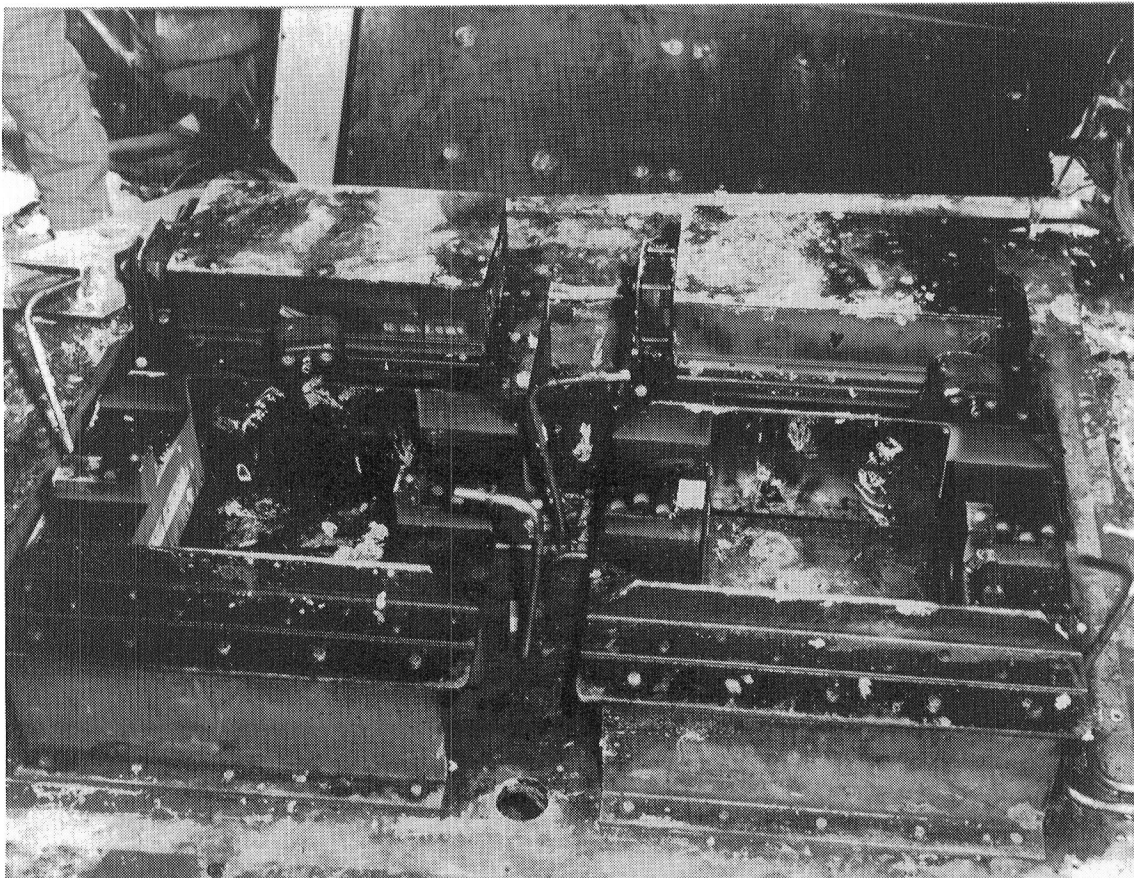
Figure 37

BATTERY PALLET (DAS #1)

This figure shows DAS #1's battery pallet after the fire.
